Clam Lake Shoreline Survey Greenbelt Report

Friends of Clam Lake
And
Three Lakes Association

January 25, 2009

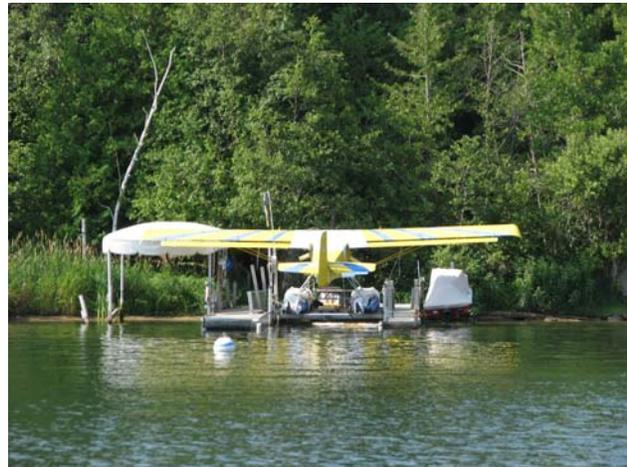
Figure 3 - Sample Shoreline Photo

Photographs were also taken from the water at the same time the survey observations were made. (Figure 3) The shoreline observations were from the high water mark back 25 feet. Thus, no data was taken on the number of boats, docks, rafts, and etc.
